DOT/FAA/AR-95/51

Nondestructive Inspection of Piper PA-25 Forward Spar Fuselage Attachment Fitting

September 1995

Final Report

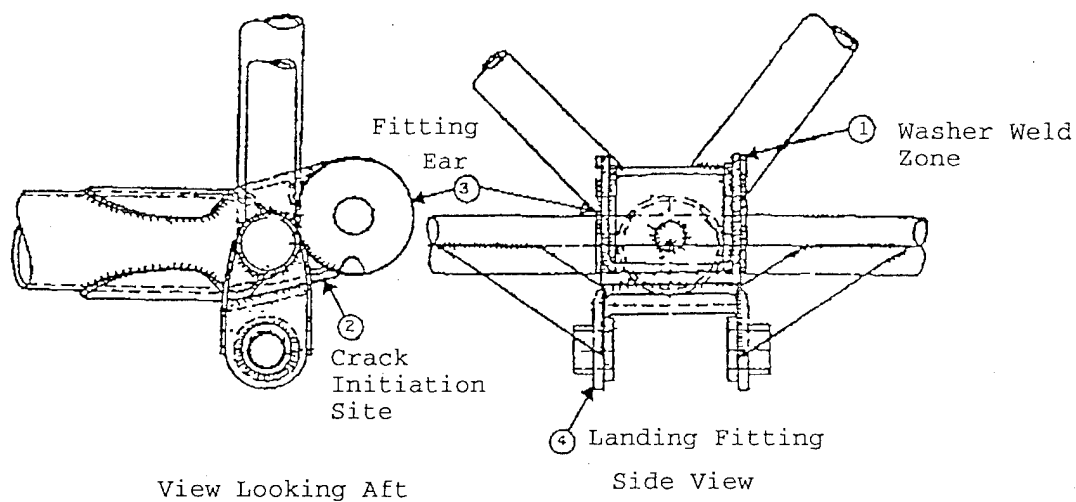
FIGURE 1. VIEW LOOKING AFT AND A SIDE VIEW OF THE SPAR ATTACHMENT FITTING FOR THE PIPER MODEL PA-25-150. FIGURE WAS TAKEN FROM AD 93-21-12.

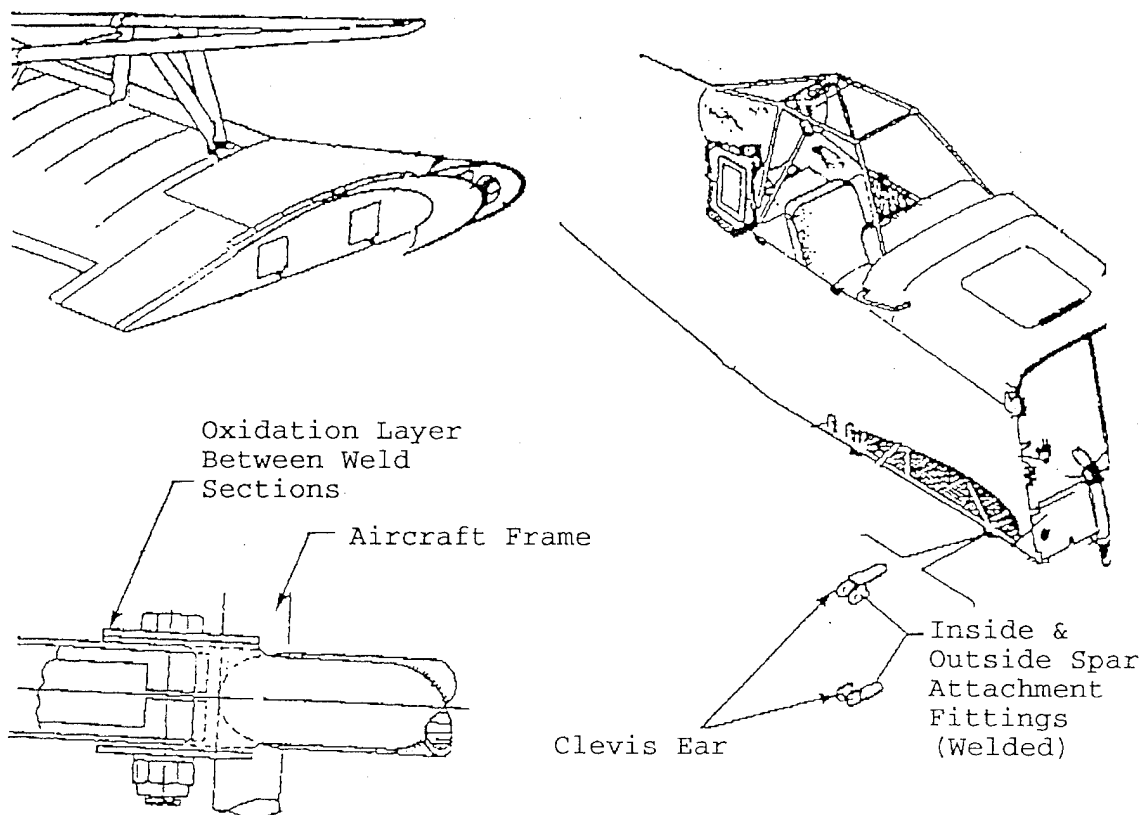
On May 21, 1993, an in-flight separation of the wing from a Piper PA-25 airplane occurred. The investigation of the affected airplane revealed corrosion and cracks in the forward spar fuselage attachment fittings. The forward spar fuselage attachment fitting consists of a clevis ear welded to a 4130 steel tube forward spar as illustrated in figures 1 and 2. This welded metal interface fractured at the base of the clevis ear. Extensive corrosion was found at the fracture site. Further review revealed that a strong oxidation layer between the two welded sections of the fitting assembly (washer and ear flange) had occurred over a long period of time. Figures 3 and 4 are photographs showing the corroded spar fuselage attachment. This airplane was used for agricultural crop dusting and had accumulated over 5,000 hours time in service (TIS) at the time of the accident. A similar accident had occurred previously on September 21, 1991, to an airplane with 10,000 hours TIS. These two different accidents alerted the FAA that an unsafe condition may exist on the Piper Model PA-25. The FAA also believes that airplanes utilized in agricultural environments are extremely susceptible to the above corrosion conditions.

FIGURE 2. LOWER ATTACHMENT FITTING EAR AS ASSEMBLED IN THE PRESENT CONFIGURATION. FIGURE WAS TAKEN FROM AD-93-21-12.

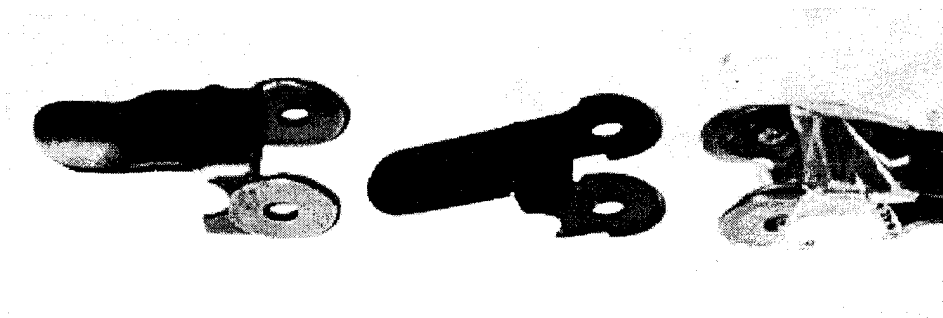
On March 4, 1994, two forward attachment spar clusters and a new Piper manufactured fitting were received from the Atlanta ACO. Sample 1 was a new, fully assembled ear fitting. To help understand the current welding process, two subassembly piece parts were also sent (figure 5). Sample 2 was a forward spar fuselage attachment cluster which had extensive pitting and surface

FIGURE 5. SAMPLE 1 - A NEW, FULLY ASSEMBLED EAR FITTING (FAR LEFT) AND TWO SUBASSEMBLY PARTS.
